**Dunnville Drinking Water System
2018 Annual Water Quality Report**

January 1, 2018 – December 31, 2018

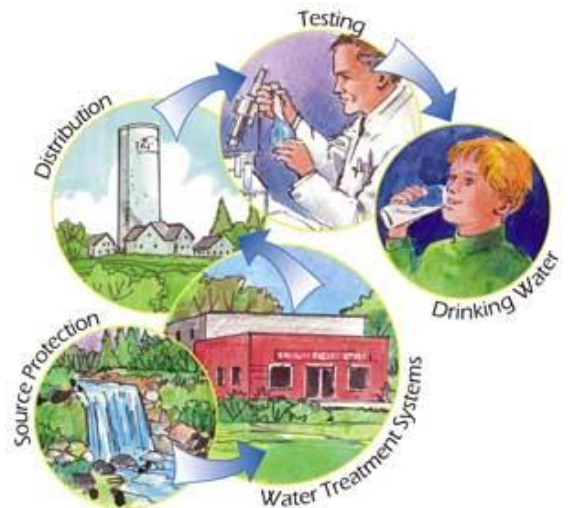
Figure 2: Responsibilities for Clean, Safe and Reliable Drinking Water

Haldimand County has adopted the multi-barrier approach in ensuring safe, reliable drinking water. *Figure 2* shows how administration, design, maintenance, and operation work together to establish and maintain multi-barrier protection (US EPA, 1998).
